Study of collapse occurred during the reinforcement work of a vault in a chalk quarry located in the north of Paris (France)

Ahmed Hosni, Baptiste Meire, Gildas Noury, Didier Pennequin. Study of collapse occurred during the reinforcement work of a vault in a chalk quarry located in the north of Paris (France). International congress on rock mechanics and rock engineering - ISRM 2019, Sep 2019, Foz do Iguassu, Brazil. hal-02241320

ABSTRACT: A vault of around ten tons weight collapsed unexpectedly during the reinforcement operations carried out in an old underground chalk quarry, which causes a serious accident. This paper describes the accident circumstances, gives some explanations for the accident, and present a simple 3 dimensional model realized to study the stability of the vault taking into account influence of local discontinuities.

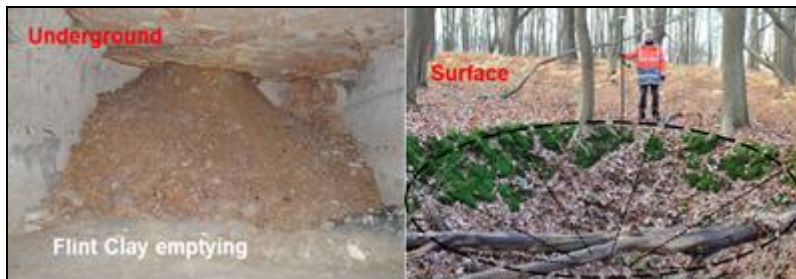
The alteration of chalk, especially development of a karstification in the covering, are quite visible on this natural profile. Indeed, the studied site is characterized by the presence of deep alteration roots in the cover, some of which have been intercepted by the mining galleries located at about 45 m depth. This geological singularity is not without consequences on the stability of the quarry, since these roots sometimes drain naturally flint clays, leading to the formation on the surface of craters of large diameters (~ 10 to 12 m) (Fig. 2).

Figure 2. Example of an alteration root intercepted at the bottom, and of the fontis induced in the surface by its emptying

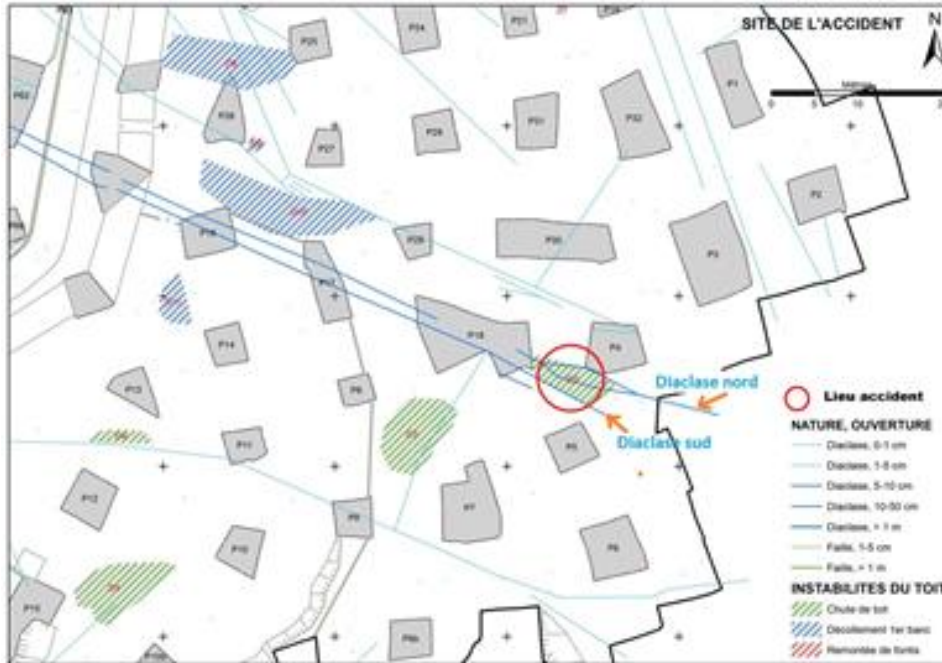
The accident occurred in an area crossed by two subparallel discontinuities. The first limited the crash area to the north, The first limited the crash area to the north, splitting into two fractures on the collapsed zone, creating a first block that had broken off when drilling a dozen holes on the roof (Fig. 6). These latest were intended to receive the bolts that were going to fix the metal beam serving to support the roof. The second discontinuity is located further south of the previous one, about 1.5 m away. It stops a few meters (~5 m) from the firm edge, on a karst cavity closed in height, probably drained of its clay filling material, well before the accident.

The accident zone is located between the P4 and P18 pillars; the zone was weakened by the presence of the two previous discontinuities. The average depth of underground work above the collapsed area would be of the order of 45 m.

At first sight, the pillars remained intact after the collapse of the vault, and no sign of settlement or occurrence of mechanical fractures were observed on the pillars after the collapse. A block with a mass of about 10 tons, bounded by the two joints, detached from the roof (Fig. 6).

Figure 6. Situation of underground work near the collapsed zone.

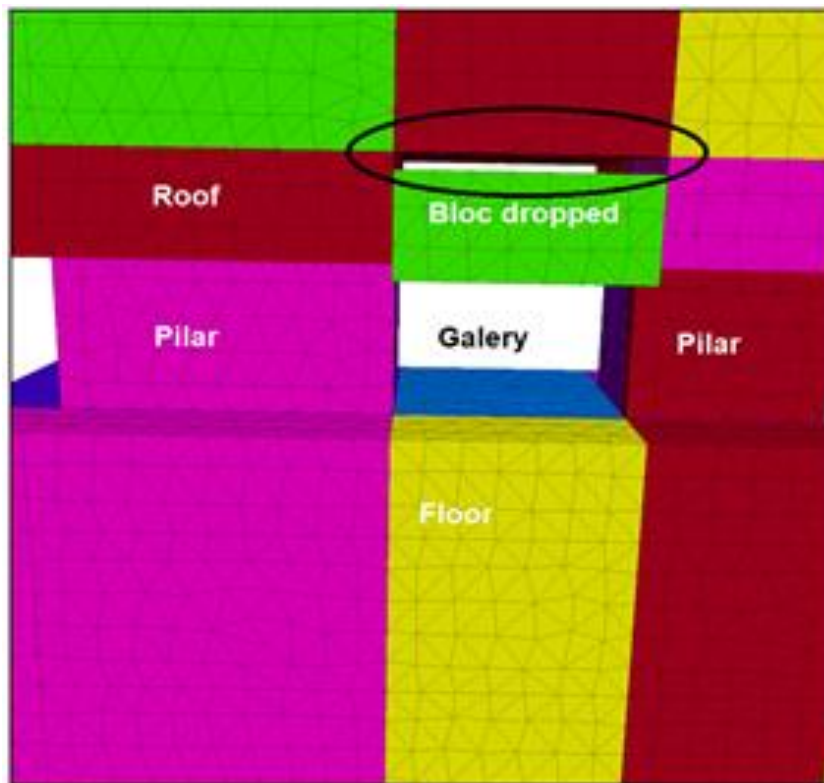
Figure 7. Simulation of the vault collapse induced by a decrease of cohesion and friction parameters.

As shown in these two Figures, the reduction of the mechanical properties (cohesion and angle of friction) of the two discontinuities inevitably leads to the rupture of the vault. We can see that the bloc dropped from the roof when the weight overcome the cohesion.

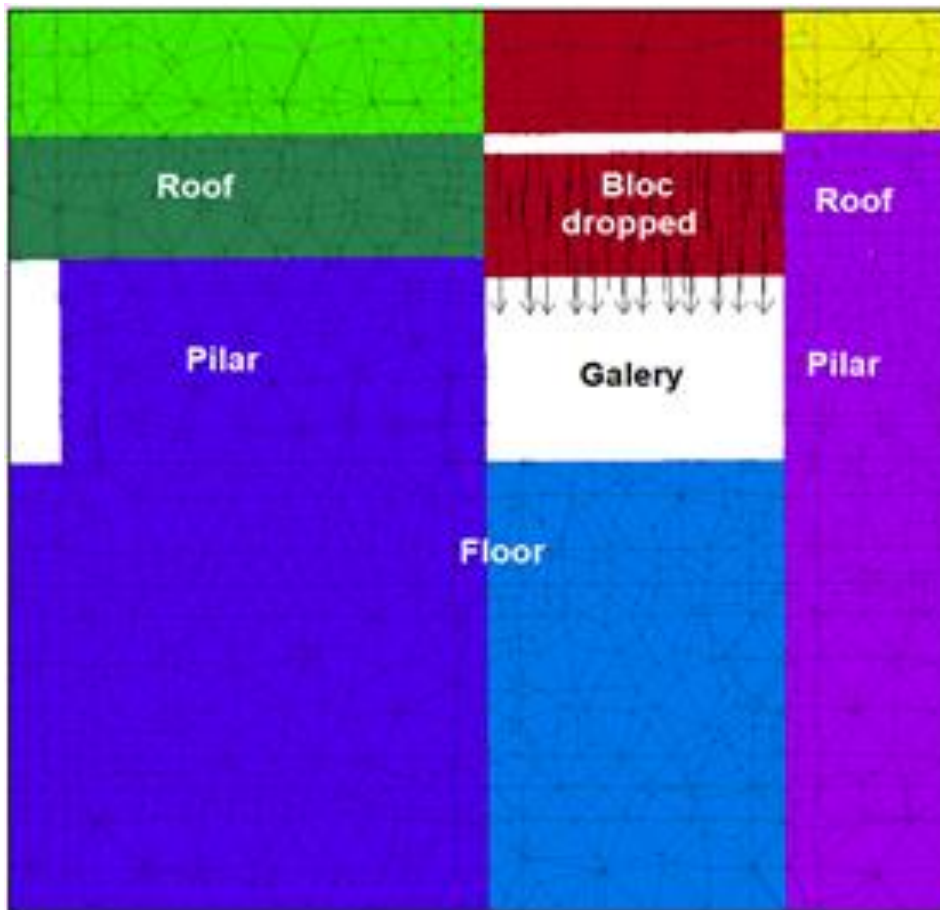
Figure 8. Simulation of the vault collapse induced by a decrease of cohesion and friction parameters (vertical cross section).
