# How Can the Morphometric Characteristics and Failure Conditions of a Historic Gully Caused by Intense Rainfall Be Reconstructed?

**Abstract:** In January 1980, during exceptional cyclonic rainfall, an atypical landslide, called *déboulé*, rapidly generated the permanent 700 m-long gully of the Ravine de l’Eglise on an inhabited plateau in Reunion Island (Indian Ocean). Retrieving the initial conditions that led to this historical process is both challenging and necessary for understanding the mechanism of gully incision and providing pointers for improving risk mitigation in relation to this phenomenon. In this study, we reconstruct the pre- and post-failure topographies using SFM (structure from motion) applied on archive aerial photographs. Based on the comparison of these digital elevation models, we estimate the volume of material eroded to be ca. 0.63 Mm<sup>3</sup>. Groundwater level increase, part of the triggering mechanism, is hindcast in the catchment of the gully using a lumped hydrological model. This model shows that in only a fortnight the groundwater level probably rose by 36 m, which could have caused a progressive increase in pore pressure and triggered formatio

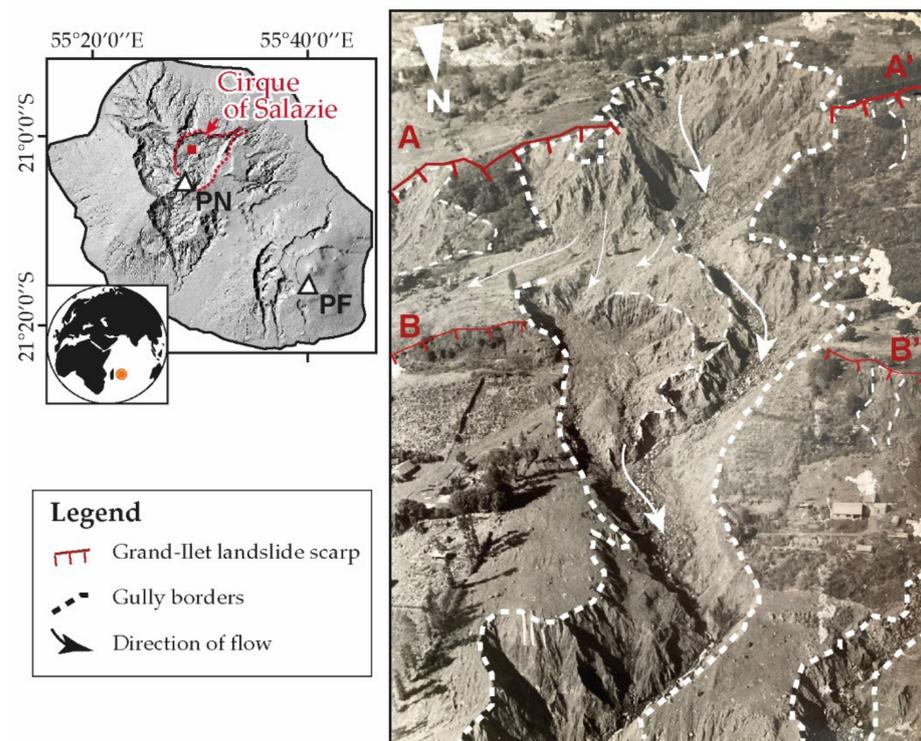
**Figure 1.** Photograph, modified from Pinchinot (1984) [8], of the *déboulé* of the Ravine de l’Eglise taken just after Cyclone Hyacinthe. The photo was taken in the field, at a date that is not exactly known. Grand Ilet is located by the red square in the image of Reunion Island to the left. PN, Piton des Neiges; PF, Piton de la Fournaise. Houses on the left side of the picture give the scale. AA’ and BB’ are scarps of Grand-Ilet landslide.

- Scarp A-A’:
  - *Head of the gully: 150 m wide, 50 m deep, head scarp slope > 45°.*
  - *Lithology: zeolitized basalt and hard layers, rust-coloured, heavily fractured.*
  - *Movement:*
    - *Initiation: possible failure of scarp A-A’ due to high pore pressure;*
    - *Progression: saturated material probably flowed rapidly downslope to the Ravine Roche à Jacquot, digging the terrain over 10 m to 30 m deep.*
  - *Springs: possible outlets along scarp A-A’ after the first collapse, which may have induced the thinning of the terrain.*
- Scarp B-B’:
  - *Head of the gully: hidden by products of the destabilization of scarp A-A’.*

- *Movement:*
  - *Initiation: possible failure of part of scarp B-B' due to high pore pressure;*
  - *Progression: the material flowed downslope but stayed quite cohesive compared to the material from the failure of scarp A-A'.*

The photo (Figure 1) shows that the resulting channel was covered by blocs of up to several meters in size, and finer materials. Water was still flowing when the picture was taken. Deposits from intersected flows suggest that several destabilization processes occurred during the rainy episode, in agreement with the description made by Pinchinot (1984) [8].

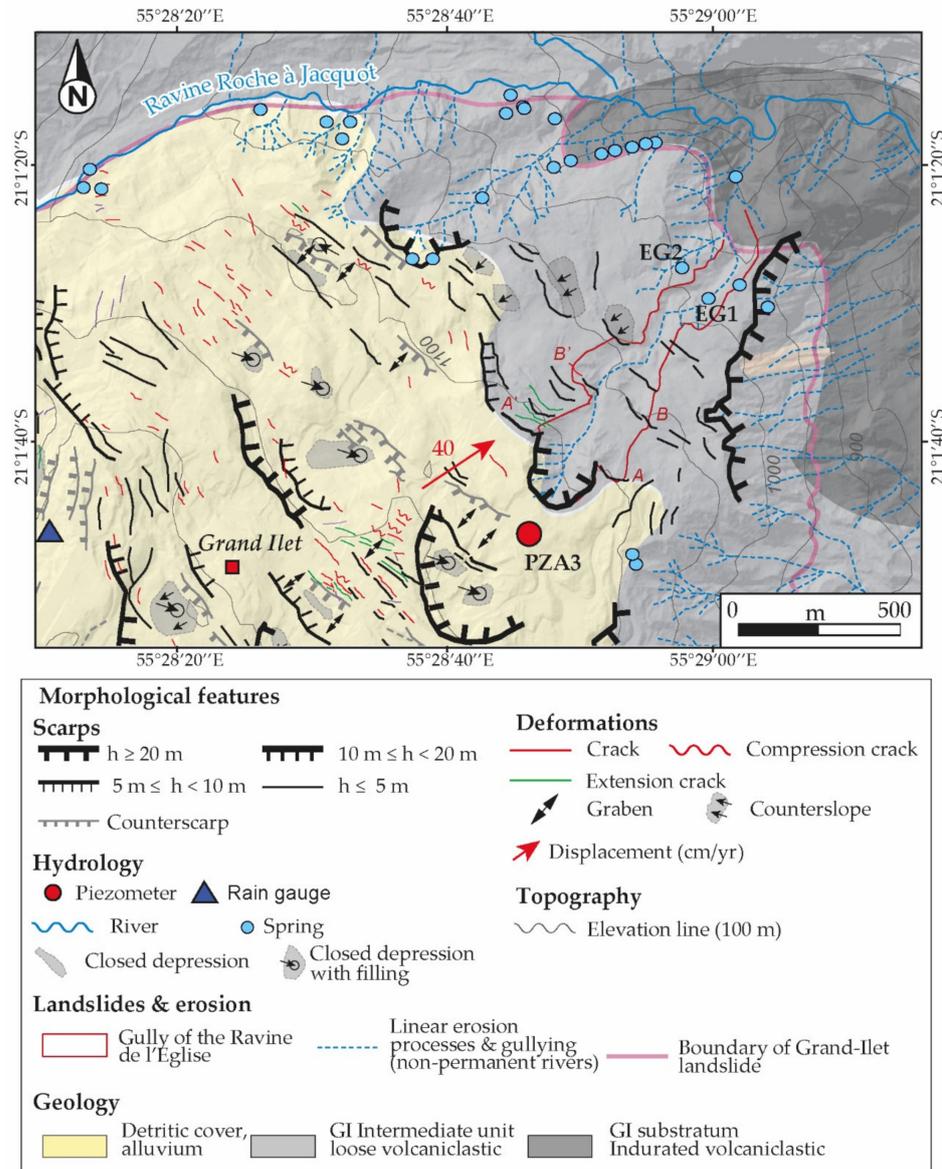
**Figure 2.** Geological and morphological settings of the gully of the Ravine de l'Eglise. EG1 and EG2: springs; PZA3: piezometer; GI: Grand Ilet. Figure adapted from Rault et al., in review [7].

The gully formed on the eastern part of the Grand Ilet landslide (Figure 2). This large compound landslide moves northeast slowly at about 40 to 50 cm·yr<sup>-1</sup> in the area of the Ravine de l'Eglise [7,46]. The mean slope of the Grand Ilet landslide is about 10°. Its surface is characterized by numerous features due to the landslide's movement (e.g., scarps, cracks,

No data concerning historic hydrological conditions was available for 1980 except the daily rainfall recorded at the Grand Ilet meteorological station located at ca. 1 km west of the head of the gully (Figure 2).

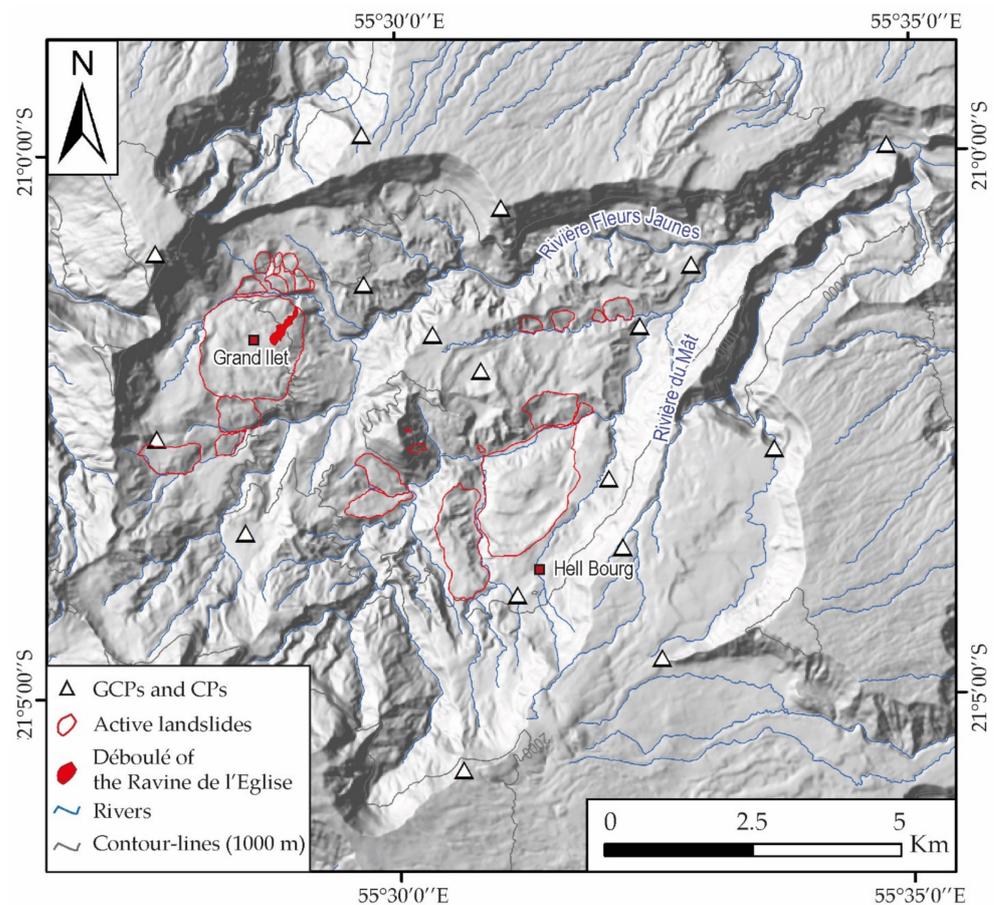
**Figure 3.** Localization of the control points used to build the 1978 and 1984 DSM and orthophotographs of the Cirque of Salazie. Most of the plateaus are occupied by active landslides [6,7,46]. GCPs: ground control points; CP: check points.

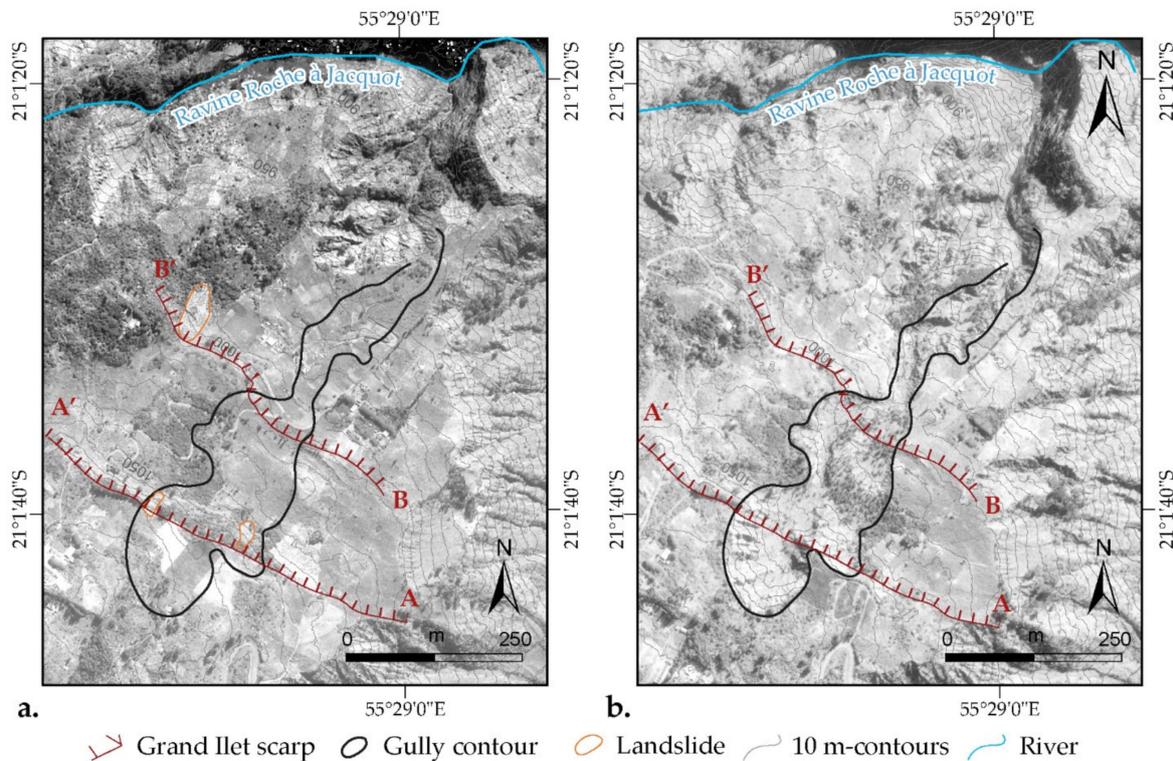
**Figure 4.** Morphological change following Cyclone Hyacinthe. (a). Orthophotograph and elevation lines of 1978. (b). Orthophotograph and elevation lines of 1984. The red lines A-A' and B-B' are the Grand Ilet scarps imaged in Figure 1. The orange polygons delineate small landslides identified on the aerial images of 1978.

Figure 4 shows the processed 0.6 m-resolution orthophotograph of 1978 and 1984 above the Ravine de l’Eglise, corresponding to the pre- and post-failure images of the surface respectively. These images are superimposed by elevation contours extracted from their respective 1 m-resolution DSMs.

In 1978, the surface was covered by agricultural fields with short vegetation. Scarps A-A' and B-B' were already active, as attested by small local landslides (Figure 4a). The elevation lines of the topography of 1978 reveal a small linear depression (ca. 5 m deep and 100 m wide), joining scarps B-B' and A-A' and ending in an active erosion area, where the *déboulé* occurred two years later (Figure S6). This depression is included in a small elongated watershed of about 0.067 km<sup>2</sup> and 744 m in length, with an average slope of 15°.

Downstream from this watershed, headward erosion had already initiated the formation of a small gully (Figures 4 and S6). These features suggest that preferential flow paths above the pre-failure surface of the gully may have existed in 1978.

In 1984, the gully head has a badland morphology (Figure 4b). The vegetation has started to grow in some areas only, suggesting that the erosion must still have been active four years after the *déboûlé*.

The maximum depth of the gully is observed at the toe of the scarps A-A'. Pre-failure and post-failure topographic profiles are presented in Figure 4c. The channel surface (topography of 1984 and 2015) is relatively smooth with a mean slope of 12°, similar to the initial topography (Figures 5c and S7). The gully has side walls from ca. 30 m to 10 m high, 30° steep (Figures 4b and S5).

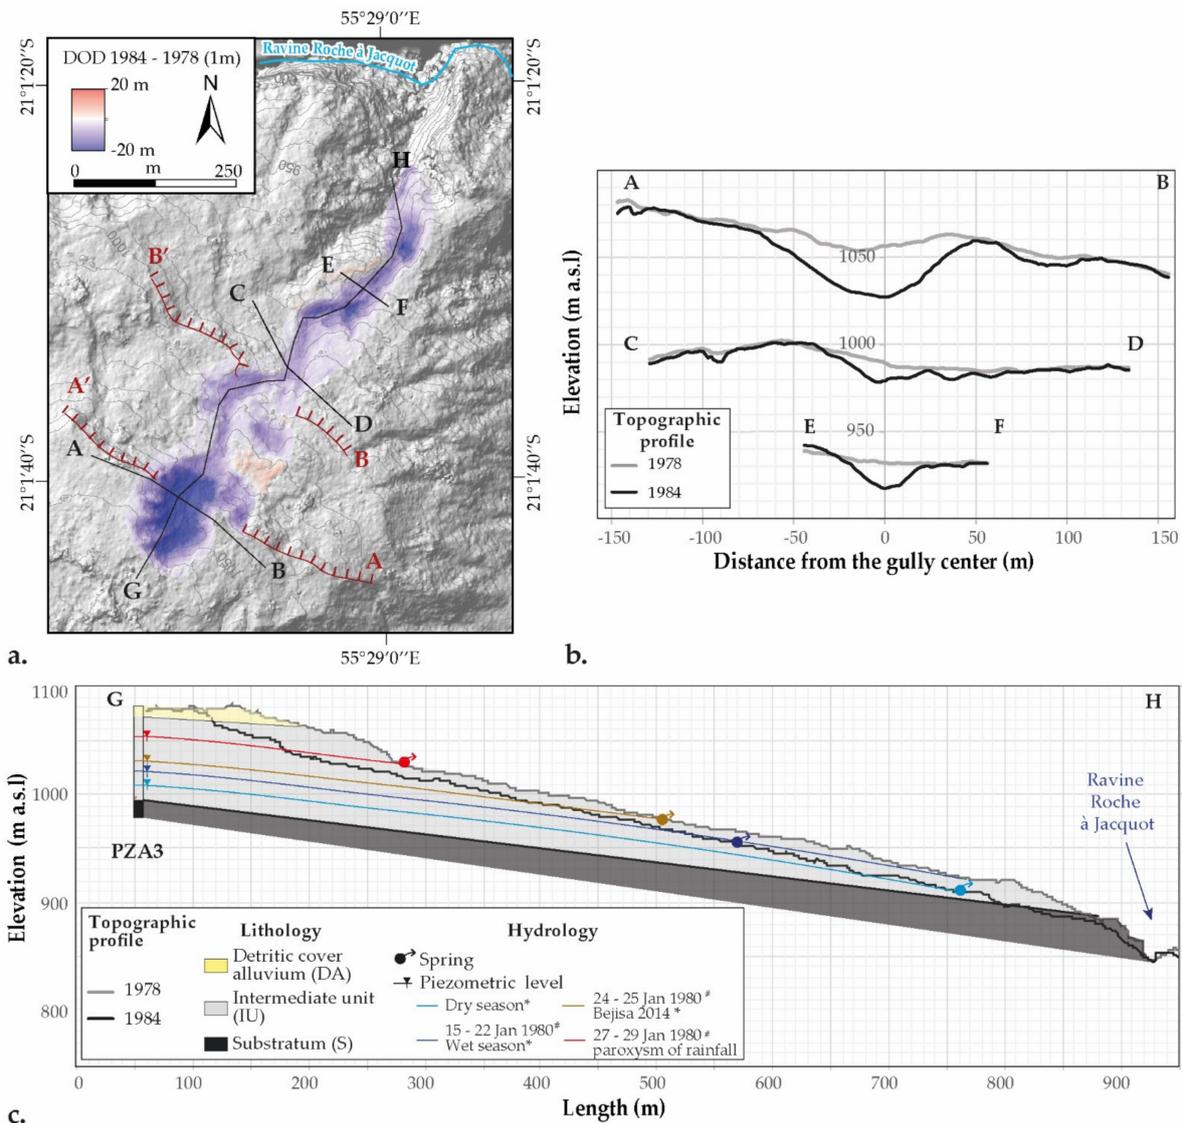
**Figure 5.** Comparison of the 1978 and 1984 topographies in the Ravine de l’Eglise watershed (a) 1 × 1 m DEM of Difference (DoD) comparing 1978 DSM and 1984 DSM calculated above the gully of the Ravine de l’Eglise. Deep blue indicates major surface excavation. The black lines A-B, C-D and E-F mark the ends of the transversal topographic profiles presented in (b) and G-F the longitudinal topographic profile presented in (c). The red lines A-A’ and B-B’ are the Grand Ilet scarps imaged in Figure 2. Light-grey lines are the 10 m elevation contours. (b) Transversal profiles of the gully. (c) Longitudinal profile of the gully with the measured and hindcast groundwater levels (see next section). #: piezometric level hindcast for Cyclone Hyacinthe, \*: piezometric level recorded.

The volume of material evacuated from the Grand Ilet plateau between 1978 and 1984 due to the formation of the gully is estimated from the difference of elevation between the 1 m-resolution digital surface model (DSM) produced of 1984 and 1978 (Figure 5a). The median absolute deviation (MAD) between these two models in a stable area is 1.45 m with a median difference of 0.73 m, which means that the elevation difference is accurate at  $0.73 \pm 1.45 \text{ m}$  (Figure S2). Furthermore, in the area of the Ravine de l'Eglise, the vegetation was quite short in 1978 and 1984 (Figure 4), which limits errors that are due to vegetation change.

The total negative difference (i.e., depletion) in the gully of the Ravine de l’Eglise is ca.  $6.3 \times 10^5 \pm 7.0 \times 10^4 \text{ m}^3$ . According to the picture of the *déboulé* taken just after it occurred (Figure 1), most of this material was rapidly evacuated downstream. The volume of material corresponds to the lower bound of the amount of material evacuated by the gully between 1978 and 1984, as the growth of vegetation and subsequent destabilizations may have induced the rise in elevation of the topography of 1984 in comparison to that of February 1980.

Reported on the pre-failure surface (Figure 5c), the maximum piezometric level of Cyclone Hyacinthe crosses the toe of the scarp A-A' that collapsed during Cyclone Hyacinthe. This is consistent with observations from inhabitants during the cyclone, who reported that sources emerged along A-A' after its collapse [6,7]. The hindcast water table north of scarp A-A' was above the ground surface. Such a groundwater level is thought to have led to an increase in pore water pressure and total stress in the whole terrain column between the surface and the less permeable substratum.

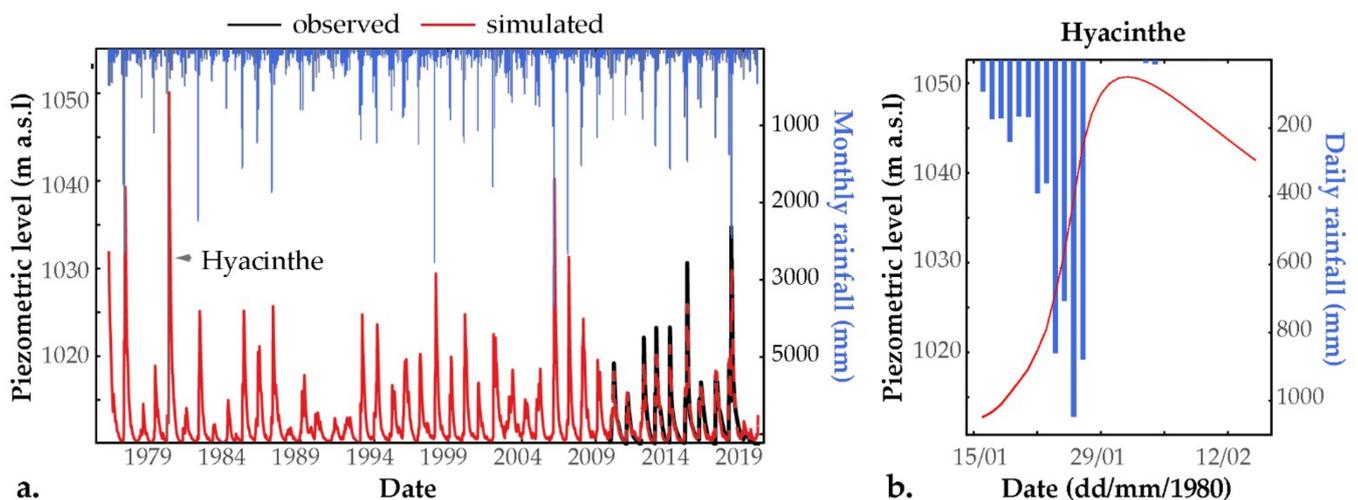
**Figure 6.** Rainfall recorded in Grand Ilet and piezometric level variation at PZA3 (see Figure 2) (a) from 1976 to 2020 and (b) during Cyclone Hyacinthe (15–27 January 1980). Blue bars are the rainfall; black and red lines are, respectively, the recorded and the hindcast water-levels since 1976. a.s.l. = above sea level.

Figure 6 shows the hindcast piezometric level of the Grand Ilet aquifer since 1978. The correlation of the measured and the modelled groundwater level from 2010 and 2020 with Gardenia® is clearly efficient, as attested by a Nash–Sutcliffe model efficiency coefficient (NSE) of 0.959. A model with an estimation error variance equal to zero has an NSE equal to 1 [64]. This good modelling allows the groundwater level to be hindcast at piezometer PZA3 from 1976 to 2010. The groundwater level just before Cyclone Hyacinthe was 1014 m above sea level (a.s.l.); i.e., in the average of those recorded during the rainy season in that piezometer. During Cyclone Hyacinthe, the water table rose progressively in response to the gradual increase in rainfall. The groundwater level may have reached at least 1050 m a.s.l., meaning an increase in groundwater of at least 36 m in only 13 days.

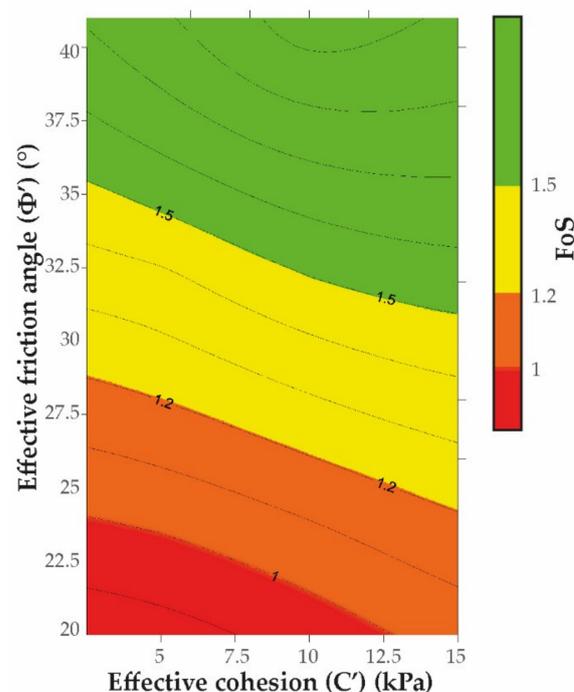
**Figure 7.** Sensitivity analysis of the intermediate unit. Slope instability along the topographic profile is obtained only at the toe of the slope under wet conditions when the  $C'$  effective cohesion and  $\Phi'$  effective friction angle have lower values. FoS: factor of safety.

Figure 7 shows the results of the sensitivity analysis under wet conditions. Under wet conditions, with a variation of  $\pm 50\%$  of  $C'$  around its average value (10 kPa), the FoS values vary by 12%. With the same conditions, by varying  $\Phi'$  by  $\pm 28\%$  around its average, the FoS values vary by about 60%.

Under wet conditions, the FoS is lower than 1 only if we consider the smaller known values of  $C'$  ( $\leq 5$  kPa) and  $\Phi'$  ( $\leq 23^\circ$ ) for the intermediate unit. Table 3 gives the parameters selected for simulation of the gully incision. Considering these parameters, scarp A-A' is at the limit of stability (FoS = 1) and the toe of the slope is unstable (FoS = 0.98) (Figure 8). This result is in agreement with the instability deformations (e.g., cracks, leaning trees) observed in the field along scarp A-A' and at the front of the Ravine de l'Eglise watershed before the gully incision.

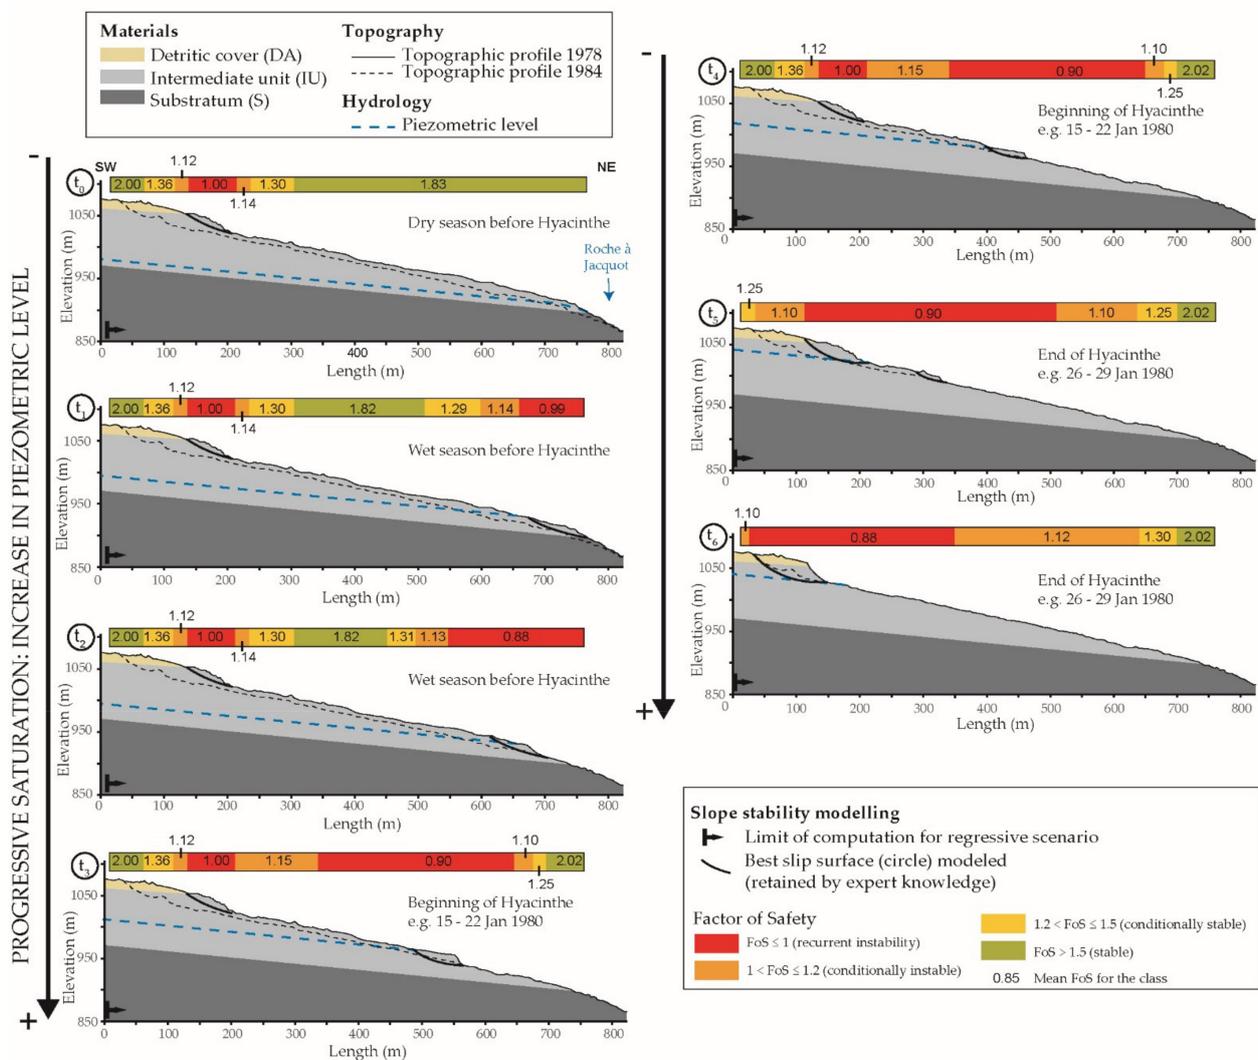
**Figure 8.** Headward retreat simulations. Scenarios  $t_0$  to  $t_6$  show the impact of the rise in groundwater level on slope stability (see text for more explanations). The mean values of FoS in the area delineated by coloured rectangles are given. Under dry conditions, the slope is stable except along the upper scarp. By increasing the groundwater level, successive retrogressive failures occur up to the current head of the gully. The values of geotechnical parameters used are in Table 3.

Our hypothesis is that the gully of the Ravine de l'Eglise was formed by successive retrogressive collapses caused by the progressive rise in the groundwater level of the Grand Ilet aquifer. Seven successive model iterations were carried out, gradually increasing the water table level from 15 m above the substratum of the Grand Ilet aquifer to ca. 80 m, corresponding, respectively, to dry conditions and saturated conditions that may have occurred during Cyclone Hyacinthe according to the Gardenia<sup>®</sup> simulation (Figures 6 and 8).

For scenario  $t_0$ , which is characterized by the initial topography of 1978 and a low groundwater level, the slope toe is stable ( $FoS > 1.5$ ), but the upstream talus corresponding to scarp A-A' is unstable to conditionally unstable ( $1 < FoS < 1.2$ ). By increasing the groundwater level by a factor of 2, as has been known to occur in the wet season, a failure takes place downstream from the watershed of the Ravine de l'Eglise and induces a headward retreat of the slope toe of about 100 m (scenario  $t_1$ ). The stability of scarp A-A' remains unchanged. With the same groundwater level, the front of the remaining topography of 1984 is unstable ( $FoS \ll 1$ ). These conditions cause the gully to retreat by ca. 150 m (scenario  $t_2$ ). Pursuing the next simulations in this way, with a piezometric level similar to that simulated for the first ten days of Cyclone Hyacinthe, we observe a succession of more or less large retrogressive destabilizations of the slope. The last scenario corresponds to the saturation of almost all of the intermediate unit, as has occurred during the last days of the Cyclone Hyacinthe rainstorm (scenario  $t_6$ ) [8,42–45]. For this scenario, we observe that the remaining slope is unstable ( $FoS \ll 1$ ) and causes a failure that reaches the current gully head. In these conditions, the post-failure topography is conditionally unstable up to 500 m down the remaining unstable head scarp ( $FoS = 1.12$ ).

For most of the scenarios, if the failure occurs along a non-circular slip surface instead of a circular one as calculated by Bishop's equations, the  $FoS$  is always lower or equal to one, which confirms the headward retreat hypothesis (Table 4). However, for the last scenario ( $t_6$ ), the  $FoS$  is equal to 1.15, which means that the slope is conditionally unstable. For this scenario, the remaining slope contains the intermediate unit but also a significant portion of detritic cover. This last unit is quite stable due to a high  $\Phi'$  and low topographic slope.
