Study of collapse occurred during the reinforcement work of a vault in a chalk quarry located in the north of Paris (France)

Ahmed Hosni, Baptiste Meire, Gildas Noury, Didier Pennequin. Study of collapse occurred during the reinforcement work of a vault in a chalk quarry located in the north of Paris (France). International congress on rock mechanics and rock engineering - ISRM 2019, Sep 2019, Foz do Iguassu, Brazil. hal-02241320

ABSTRACT: A vault of around ten tons weight collapsed unexpectedly during the reinforcement operations carried out in an old underground chalk quarry, which causes a serious accident. This paper describes the accident circumstances, gives some explanations for the accident, and present a simple 3 dimensional model realized to study the stability of the vault taking into account influence of local discontinuities.

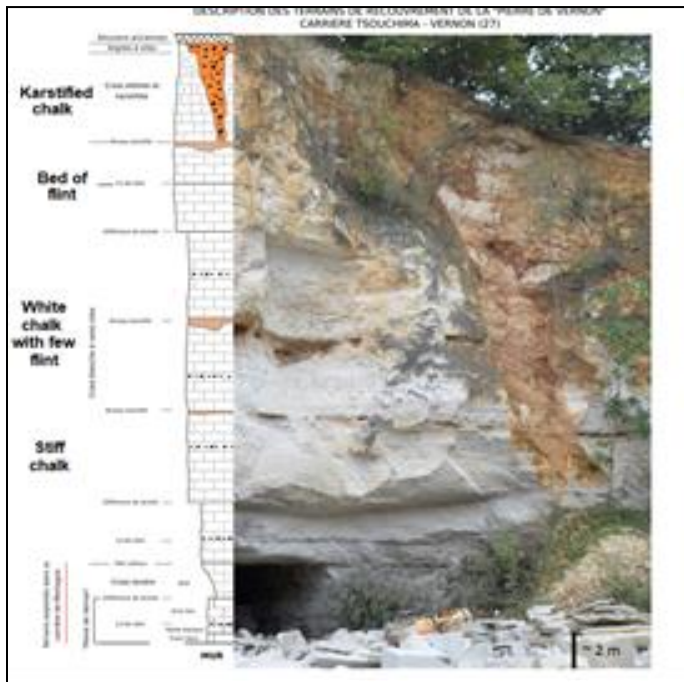
On the upper part of the roof of the quarry, the Coniacian-Santonian chalk would be covered with old alluvium from the Seine (very high alluvium, dated Pliocene), characterized by plates of blunted pebbles, sometimes a few meters thick. A representative geological profile of quarry roof is visible from about 400 m (Fig. 1).

Figure 1. Overburden geology over the quarry (mainly chalked layers).

The alteration of chalk, especially development of a karstification in the covering, are quite visible on this natural profile. Indeed, the studied site is characterized by the presence of deep alteration roots in the cover, some of which have been intercepted by the mining galleries located at about 45 m depth. This geological singularity is not without consequences on the stability of the quarry, since these roots sometimes drain naturally flint clays, leading to the formation on the surface of craters of large diameters (~ 10 to 12 m) (Fig. 2).

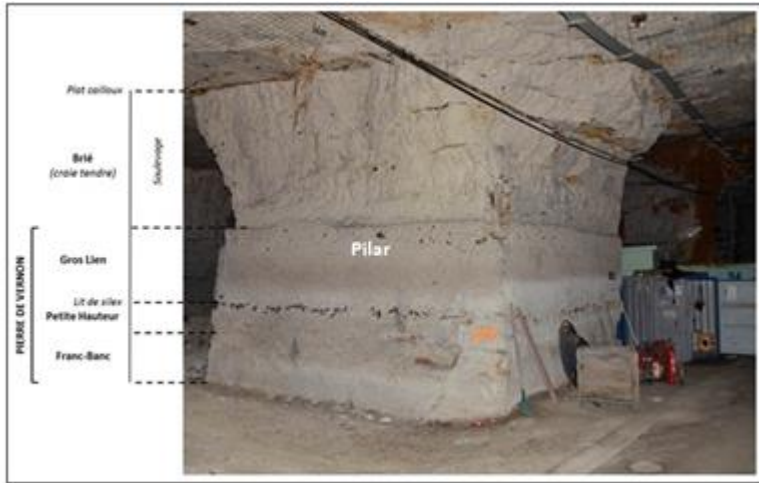
- The 'Franc-Banc', located at the base and excavated on about 90 cm thick;
- The 'Petite Hauteur' or 'small height', exploited about 40 to 60 cm thick, separated from the 'Franc-Banc' by the 'lit Franc' or 'bed Franc';
- The 'Gros Lien', exploited about 60 cm thick, separated from the two benches beneath by a bed of flint clearly visible in the quarry.

Figure 3. Local geology at a pillar scale

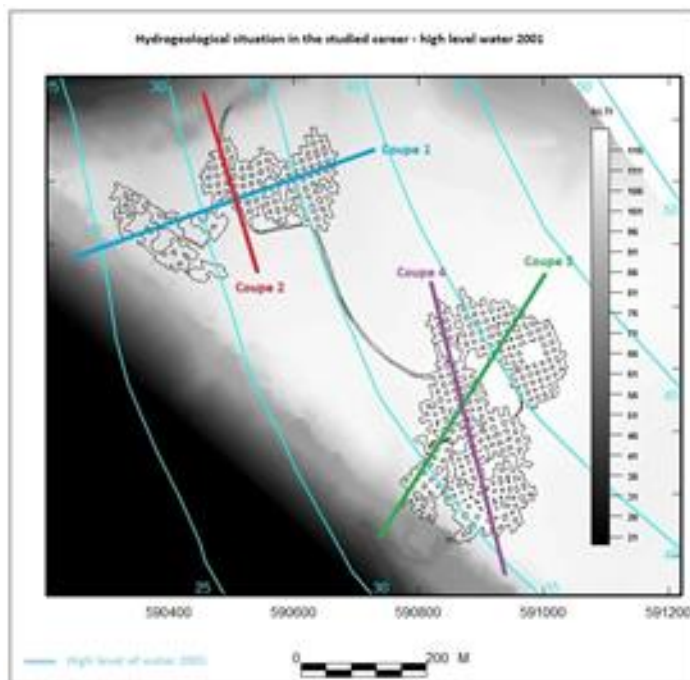
Chalk represent the main aquifer on the quarry. According to the geological atlas published by the BRGM in the studied area (Fig. 4), the altitude of the roof of the aquifer at the plateau level is between + 30 m and + 40 m NGF (for a medium water level). In other words, between 70 and 80 m depth in relation to the surface perpendicular to the quarry, and between 30 and 50 m deep compared to the level of the bottom of the quarry (overall between +72 m and + 82 m NGF).

This precludes the possibility of a flood of the underground quarry by an increase level of water table.

Figure 4. Hydrology situation on the quarry (data from BRGM/ SIGES-SN)

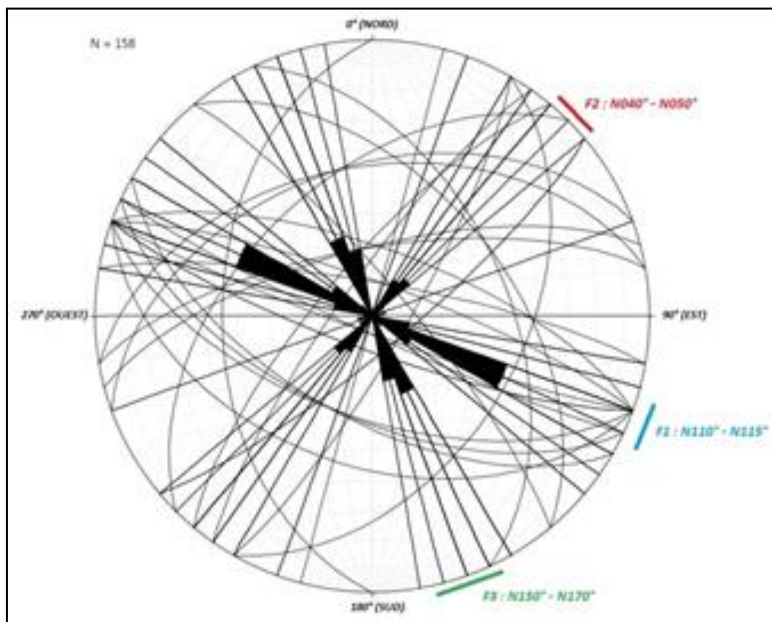
The projection on a Schmidt diagrams (bottom hemisphere) of the 158 observed natural fractures (faults or diachases), highlights three main orientations (three family) which are consistent with the regional ones (Fig. 5).

- Family F1: with a mean orientation between N110 ° and N115 °. This fracture family is essentially represented by diachases predominantly vertical or steeply dipping (greater than 75 °). This is a regional orientation, which is found in particular on the chalky cliffs of the coastal coast of the Caux country.
- Family F2: with a mean orientation between N040 ° and N050°. This fracture family is essentially represented by predominantly vertical or steeply diachases (> 75 ° or 80 °). This is a regional orientation, orthogonal to the previous one (F1).
- Family F3: fracture family only represented by vertical diachases, which follows a regional orientation and in particular those major tectonic accidents inherited from the basement (Armorican orientation).

Note that the area of the accident is crossed by two diachases belonging to the F1 family.

Figure 5. Projection on the Schmidt Diagram (south hemisphere) of the three family fractures observed in the chalk studied quarry.
